# Manhole Inspection Summary

Manhole # S61K\_\_003MH

Insp Date: **3/25/08 10:04 AM**

**Location** Address: **814 Quail St.**

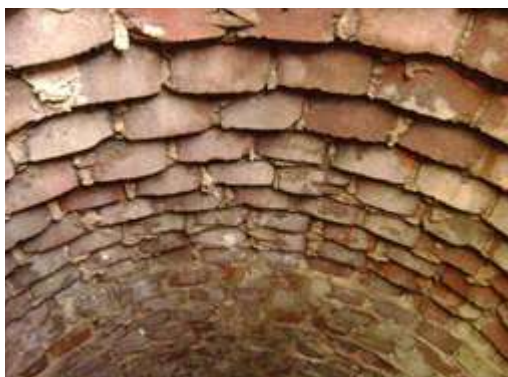
Defect 1

infiltration in barrel

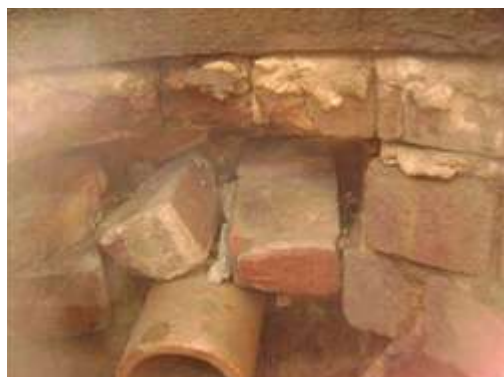
Defect 3

Condition: ☐ Sound ☐ Cracked ☐ Root Intrusion ☒ **Loose Brick** ☐ Deteriorated

Infiltration: ☐ None ☒ **Joint** ☐ Cracks ☒ **Mortar** ☐ Roots ☐ Wall

loose bricks above incoming 1 o'clock

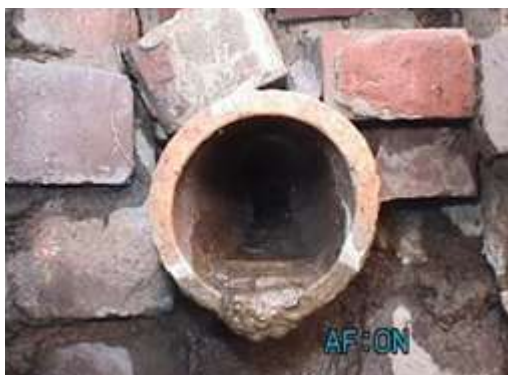
Defect 3

Broken pipe seal 3:00-7:00 at incoming 1 o'clock

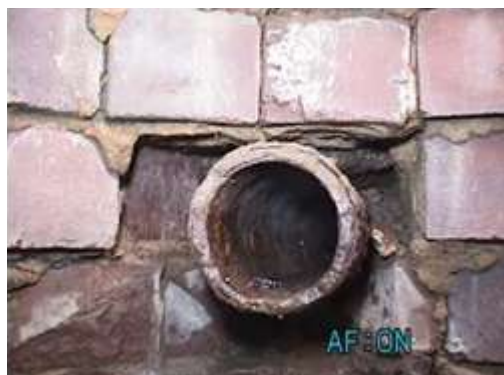
Defect 4

Broken pipe seal 5:00-7:00 on incoming 2 o'clock

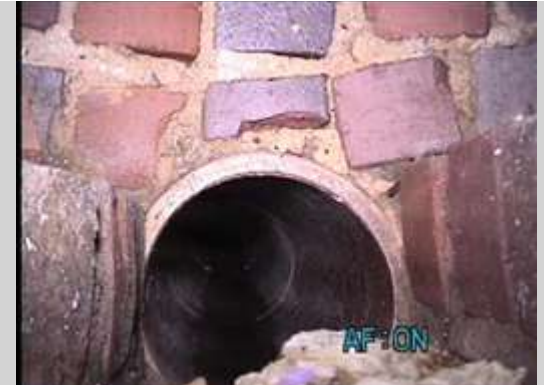
12 O'Clock Outflow

Pipe Height: **8.4** (in.) Rod and Bar (Angled)  
Pipe Material: **Clay** ☐ Pipe Lined  
Invert Depth: **9.29** (ft.) Flow Characteristics: **Slow**  
Deposits: ☒ None ☐ Mud ☐ Sludge ☐ Debris ☐ Grease  
Silt Depth: (in.) Deposits Extent:  
Infiltration: **None** Pipe Seal Cond: **Sound**

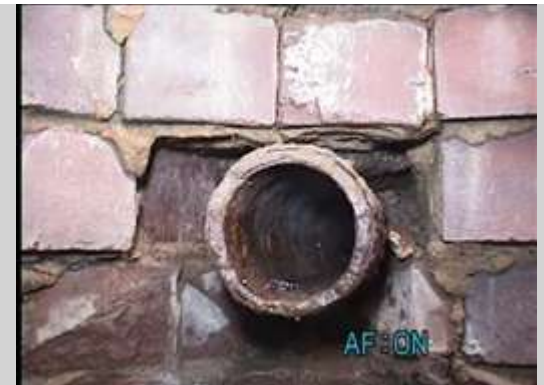
2 O'Clock Inflow

3inch pipe comin in at 2o'clock 15incjes from top/

Pipe Height: **4.8** (in.) Rod Only  
Pipe Material: **Clay** ☐ Pipe Lined  
Invert Depth: **1.90** (ft.) Flow Characteristics: **Slow**  
Deposits: ☒ None ☐ Mud ☐ Sludge ☐ Debris ☐ Grease  
Silt Depth: (in.) Deposits Extent:  
Infiltration: **None** Pipe Seal Cond: **Broken**

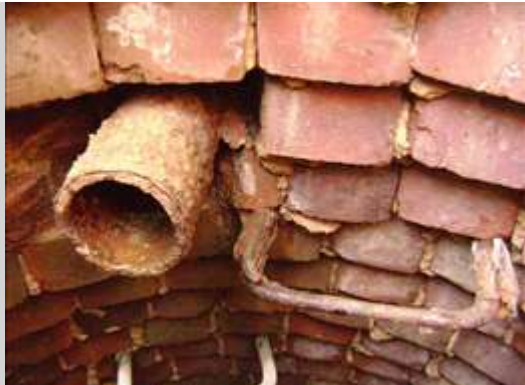
5 O'Clock Inflow

Comments **5 O'CLOCK PIPE IS ONLY 2 INCHES BUT MIAS WON'T LET YOU PUT ANYTHING UNDER 4 INCHES.**

loose bricks

Pipe Height: **2.4** (in.) Rod Only

Pipe Seal Cond: **Broken**

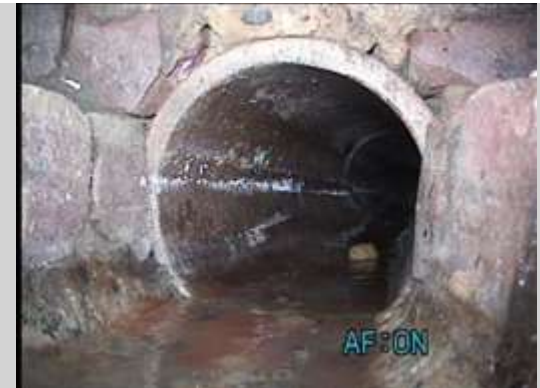
9 O'Clock Inflow

Pipe Height: **8.4** (in.) Rod and Bar (Angled)

Pipe Seal Cond: **Sound**
